LAKE LOTAWANA DAM
JACKSON COUNTY, MISSOURI
MO. 20040

PHASE 1 INSPECTION REPORT NATIONAL DAM SAFETY PROGRAM

PHASE I INSPECTION REPORT
NATIONAL DAM SAFETY PROGRAM

Name of Dam	Lake Lotawana Dam
State Located	Missouri
County Located	Jackson County
Stream	West Fork of Sni-A-Bar Creek
Date of Inspection	24 August 1978

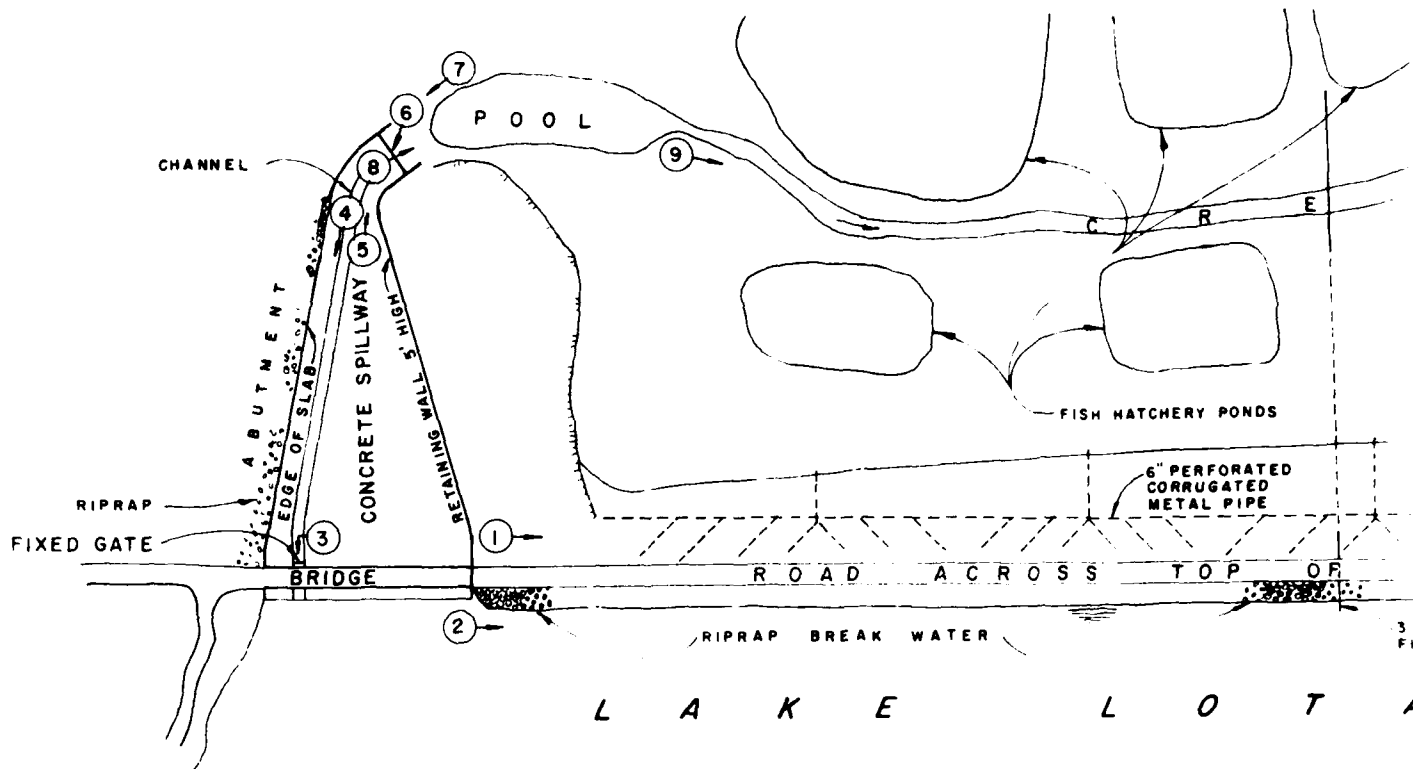
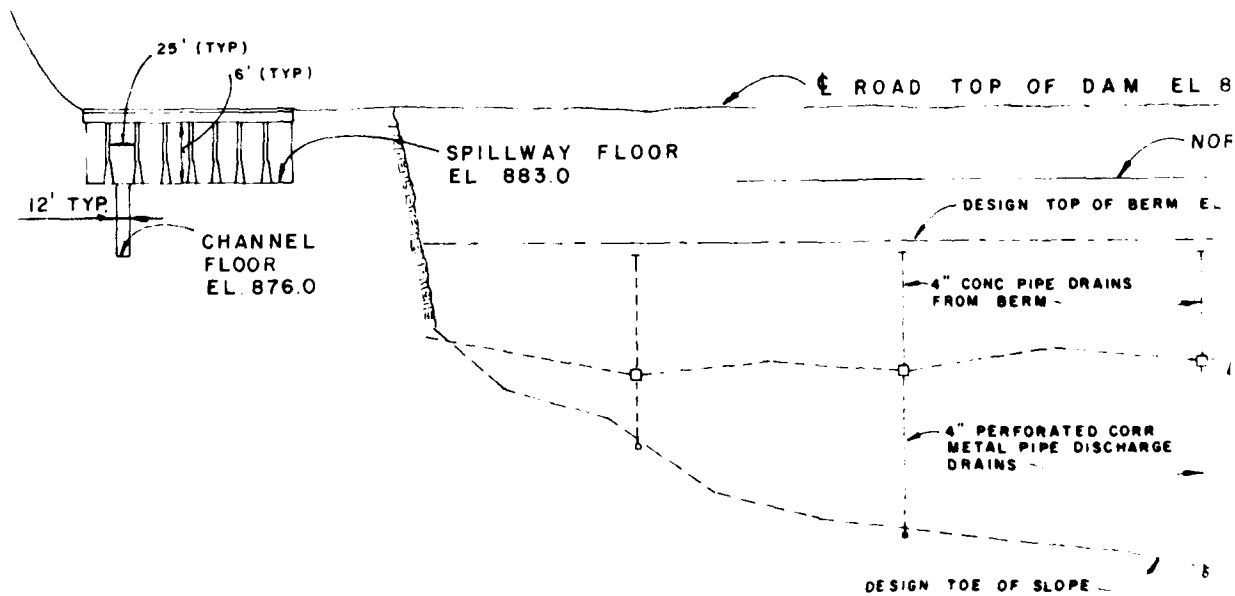
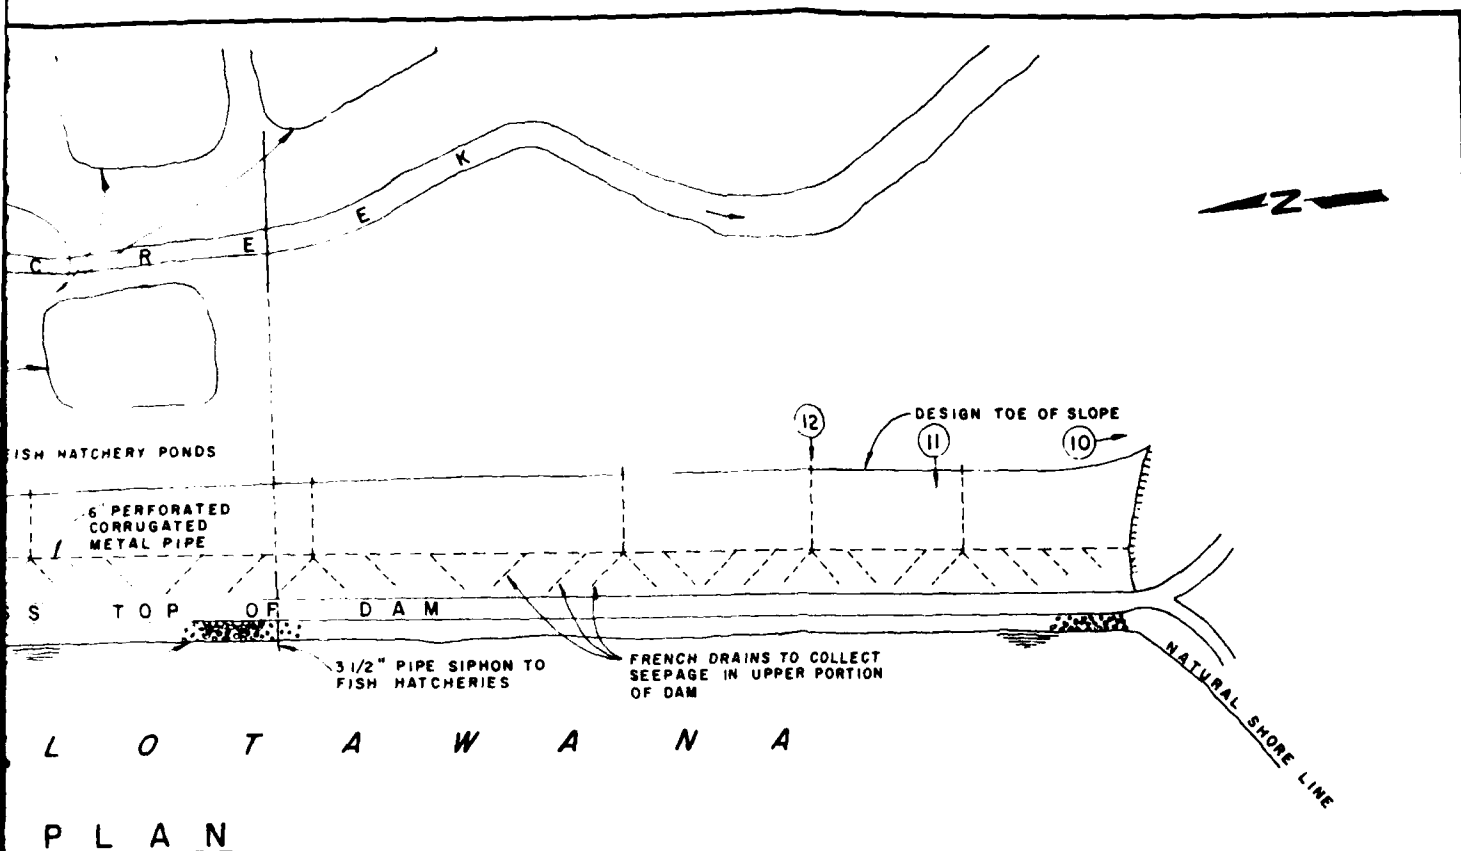
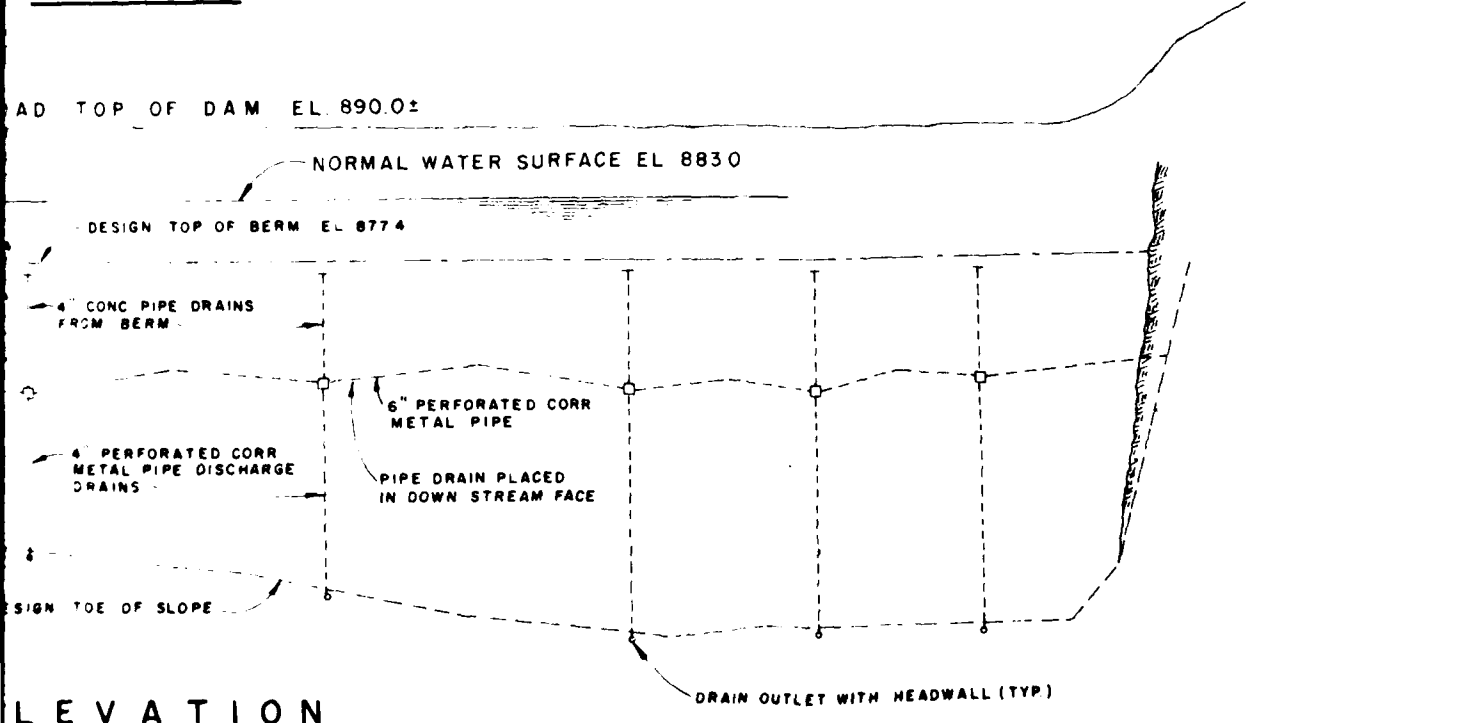
LAKE LOTAWANA
PLAN AND ELEVATION

(3) A wooden decked bridge crosses the spillway at the north abutment and a paved road continues across the dam. The bridge consists of a wooden deck supported by seven concrete piers (see Plate 3).

(4) A 3.5 inch siphon used to supply water to the fish hatchery ponds immediately downstream of Lake Lotawana is located approximately at the mid-point of the dam (see Plate 3).

c. Appurtenant Structures. The spillway is a concrete apron with a 7 by 12 feet, concrete lined channel constructed parallel to the north edge of the spillway slab. The spillway apron and channel continue east from the edge of the lake 382 feet to the crest of the curved outlet channel. The spillway then directs its discharge to the south, then drops 5 feet to a shale shelf and stream channel. Areas of small concrete spalls were observed on the spillway apron and outlet channel. Erosion was evident behind the north training wall of the spillway outlet. Minor seepage could be seen coming from a weep hole on the incline of the outlet channel. The weep hole on the vertical face of the outlet channel was dry. Minor erosion was observed in the stream channel. A 3.5 inch diameter siphon located at the mid-point of the dam was operating at the time of the inspection. Extremely moist soil was noted in the area to the south of the fish hatchery pond closest to the siphon on the west side of the creek (downstream channel) (see Plate 3).

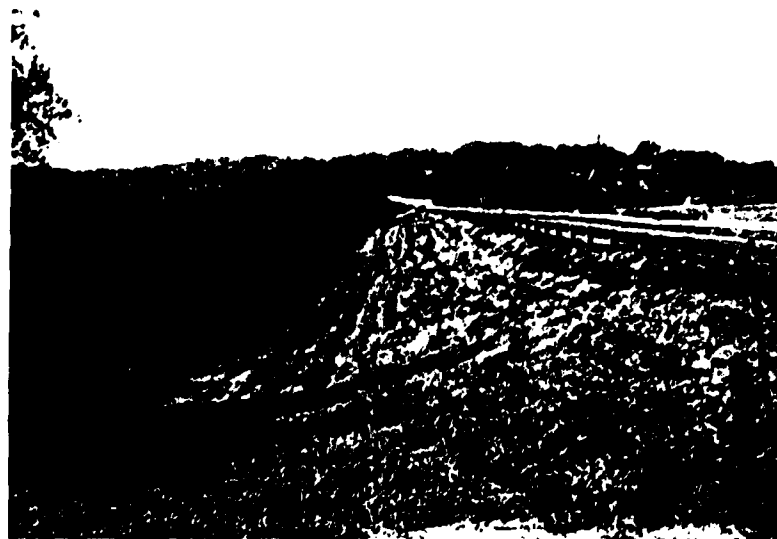
PHOTO 1: DOWNSTREAM FACE OF DAM (LOOKING SOUTH)

(6) A regular maintenance program should be initiated to control the growth on the downstream slope of the dam.

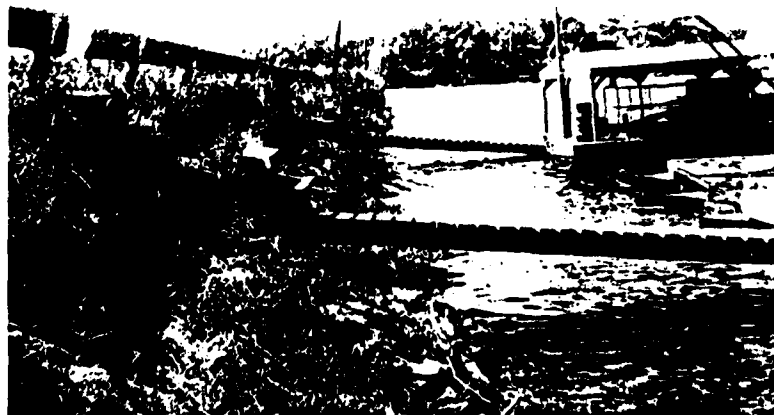
PHOTO 2: UPSTREAM FACE OF DAM (LOOKING SOUTH)

(3) The riprap surface on the upstream face should be repaired to prevent further erosion of embankment material.

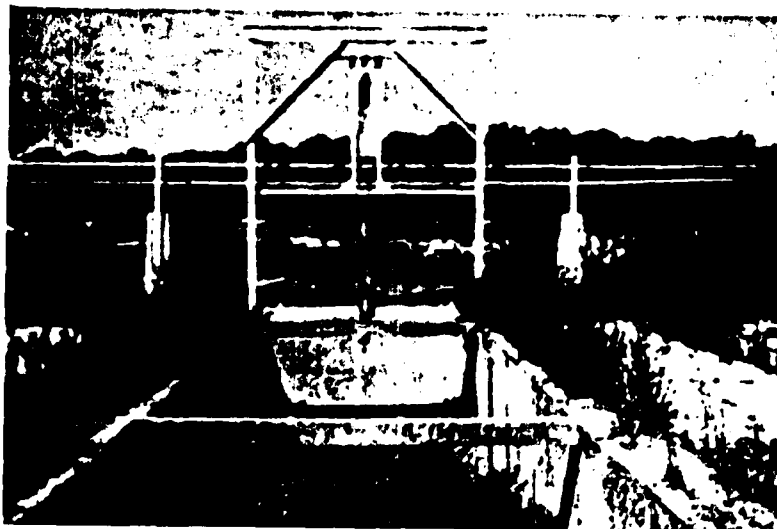
(2) A concrete lined spillway channel was constructed after excavation of the limestone strata in the north abutment. A 7 by 12 feet channel was excavated within the spillway apron to permit lake drawdown of 7 feet during the reconstruction of the dam crest and downstream face. A vertical lift gate was provided to prohibit flow into the 7 by 12 feet channel. The lift mechanism and gate have been welded in place and are not operable.

PHOTO 3: VERTICAL LIFT GATE AND BRIDGE OVER SPILLWAY

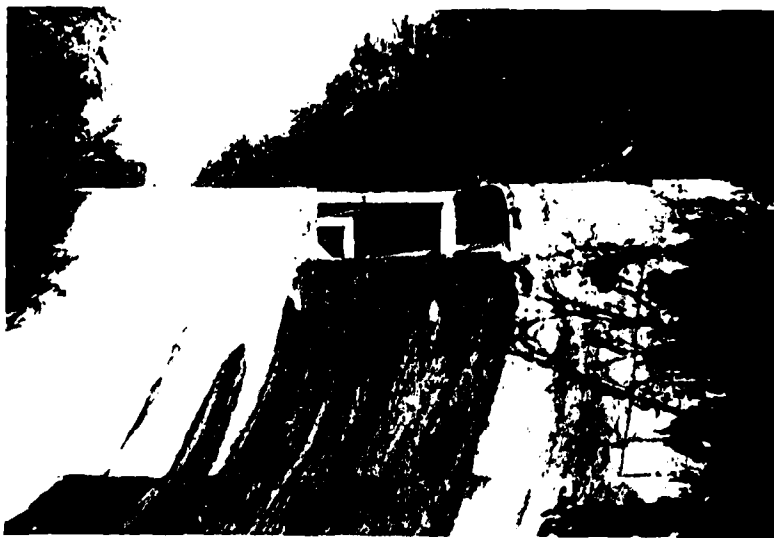
(1) Concrete spillway and the spillway discharge channel are in good condition. Seepage was observed from the weep hole on the inclined face of the spillway outlet at the end of the channel. Minor erosion was noted behind the north training wall of the spillway outlet.

PHOTO 6: SPILLWAY DROP AND END OF CHANNEL (LOOKING UPSTREAM)

(2) Measures to curtail seepage along the spillway and south abutment could be undertaken to minimize water loss and potential hazards.
